C.P.
ENVIRONMENTAL

MICRONICS ENGINEERED FILTRATION GROUP

UNITED
PROCESS
CONTROL

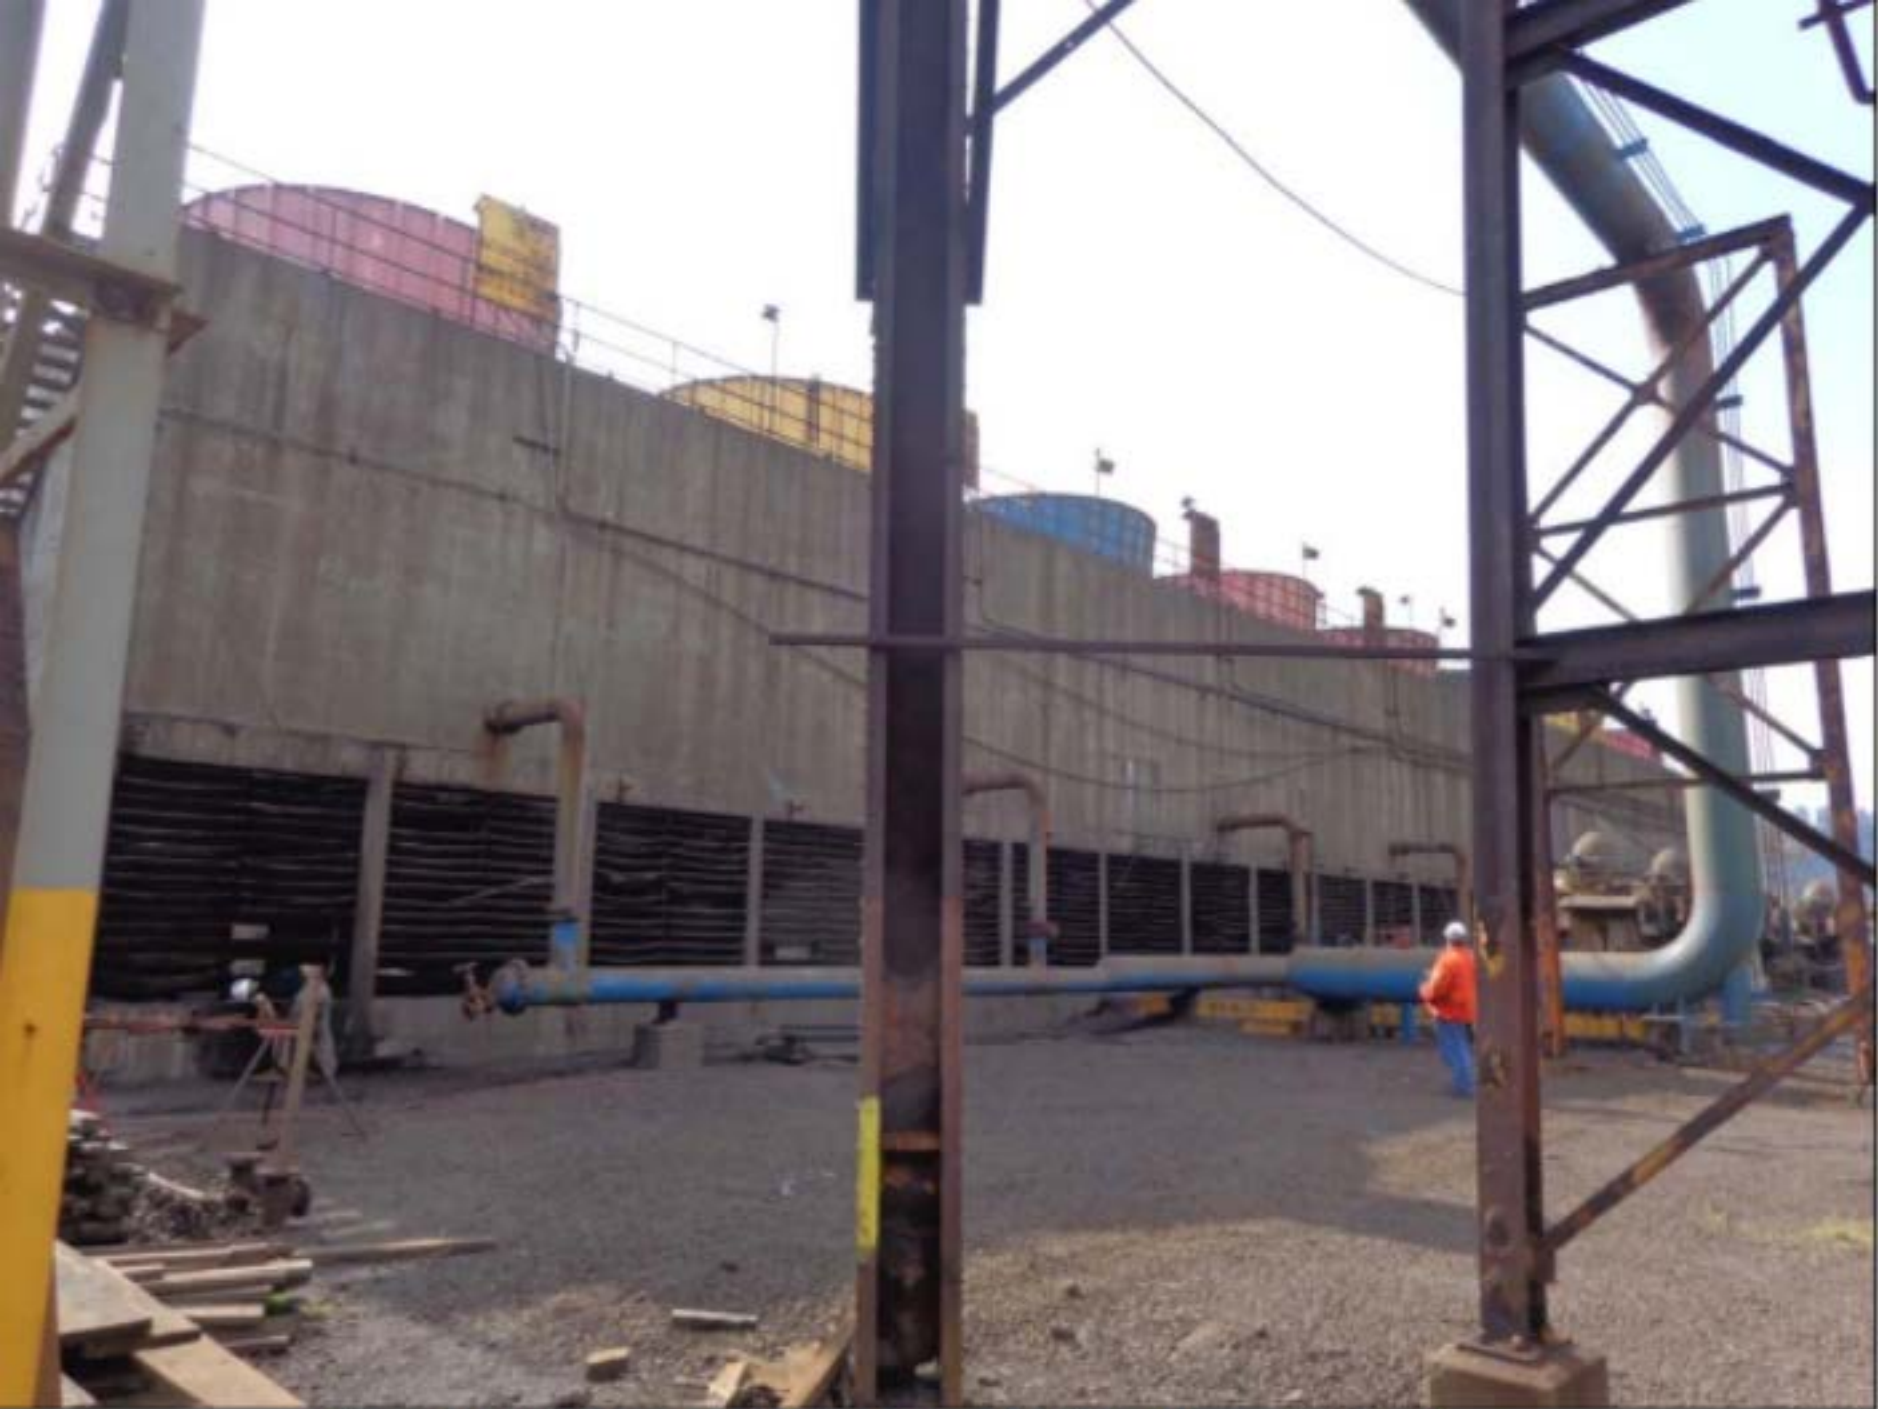
Figure 17: Blast Furnace Recirculation Scrubber Water Cooling Tower.

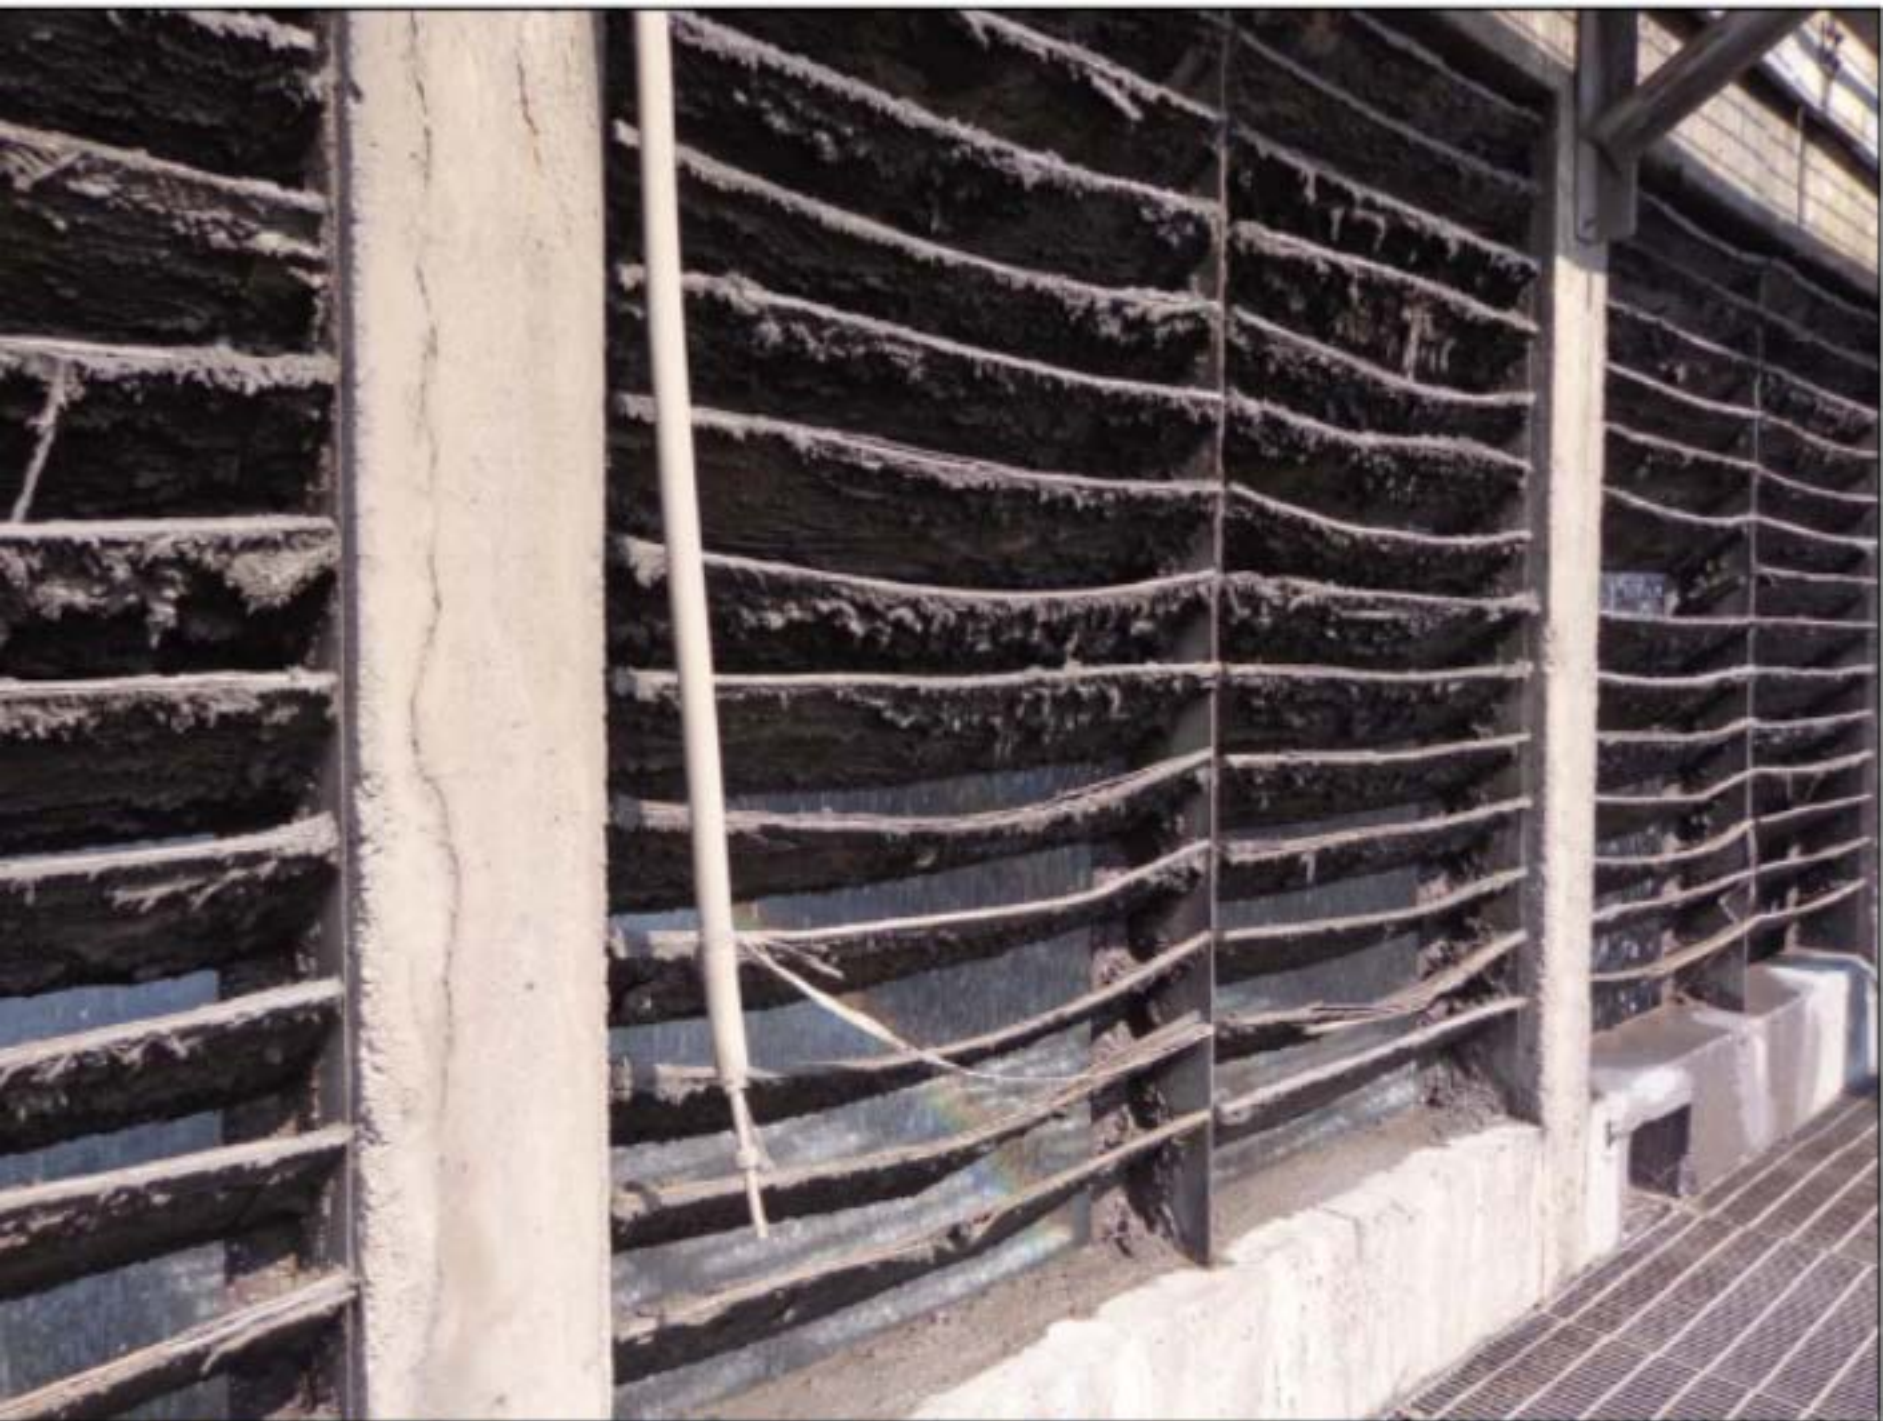
Figure 18: Blast Furnace Recirculation Scrubber Water Cooling Tower louver deterioration.

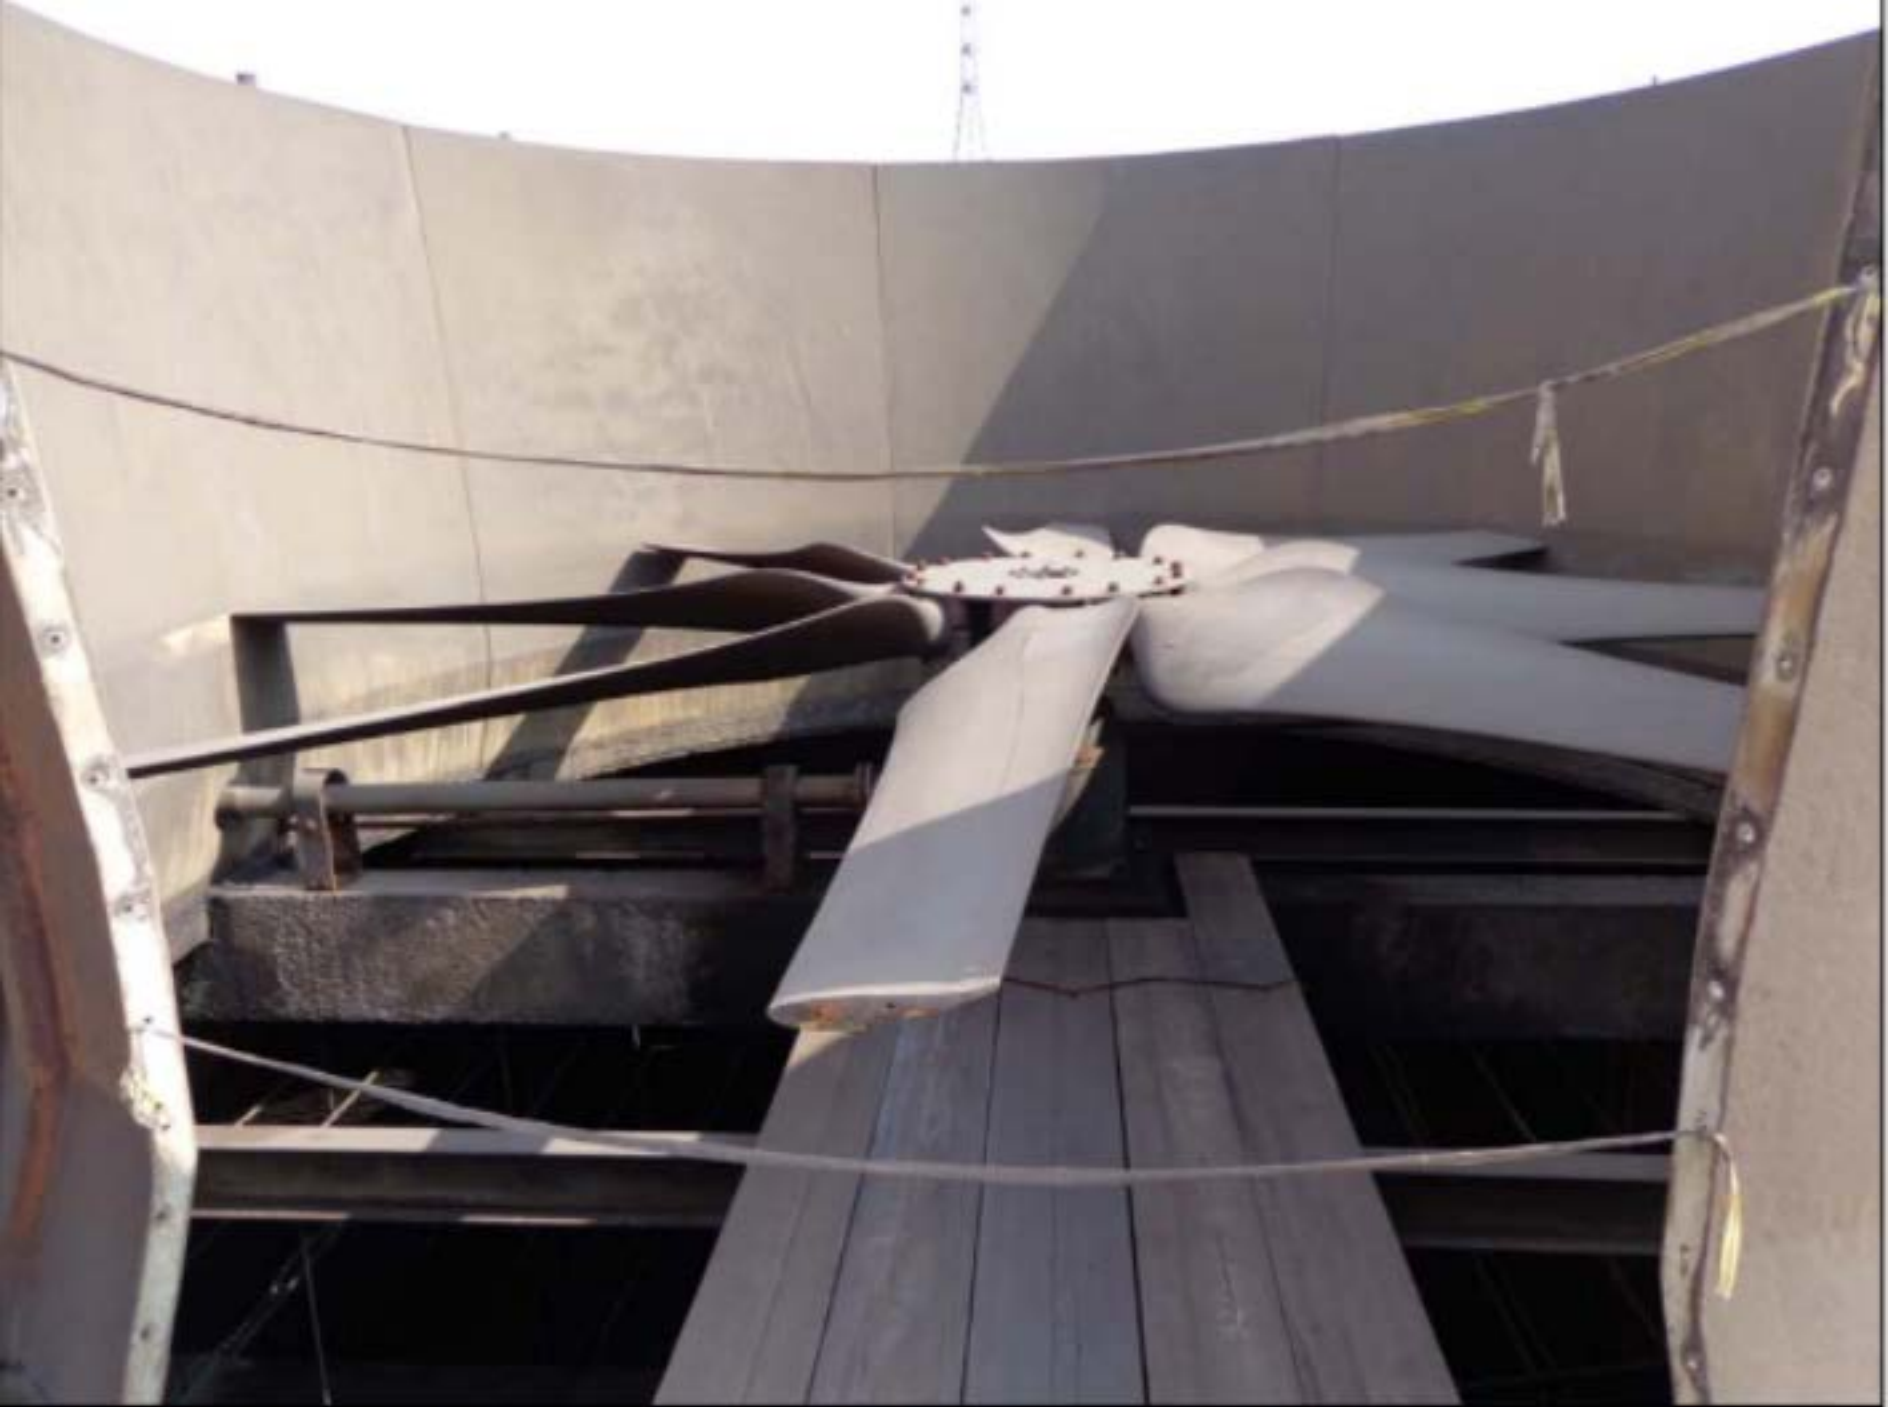
Figure 19: Blast Furnace Recirculation Scrubber Water Cooling Tower fan with leading edge wear and damage. Fan is also missing the center seal disk.

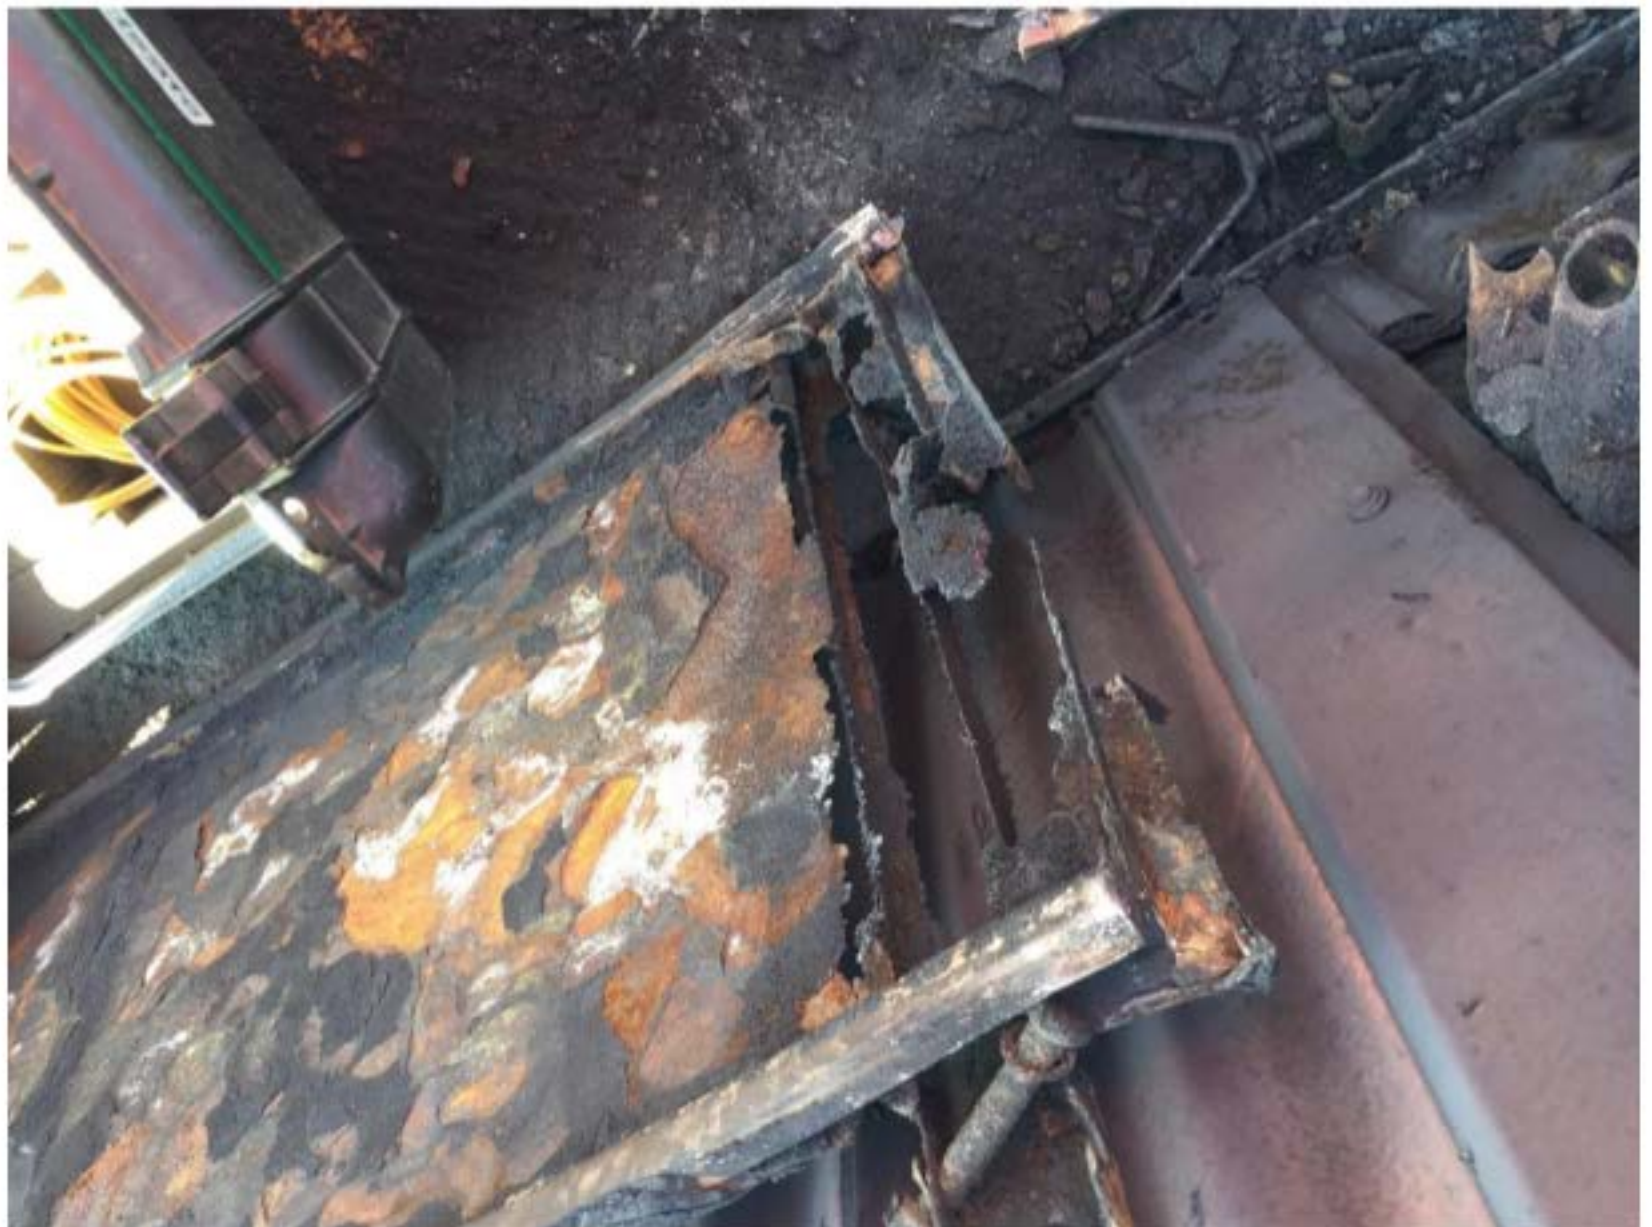
- Air to first header, 10 rows, turned off due to leakage on #4 pulse valve
- Bleed through with moderate build-up on tube sheet due to lack of cleaning
- Multiple blow pipes loose from valves
- Air leakage on solenoid box, valve #4 from door
- Crack with air leakage on last header
- Heavy build-up on tube sheet at front wall. Potential weld cracking at baffle interface
- Door corroded completely through
- Door frame needs rework as it has corroded substantially

Figure 13 Door Corrosion Door removed from unit

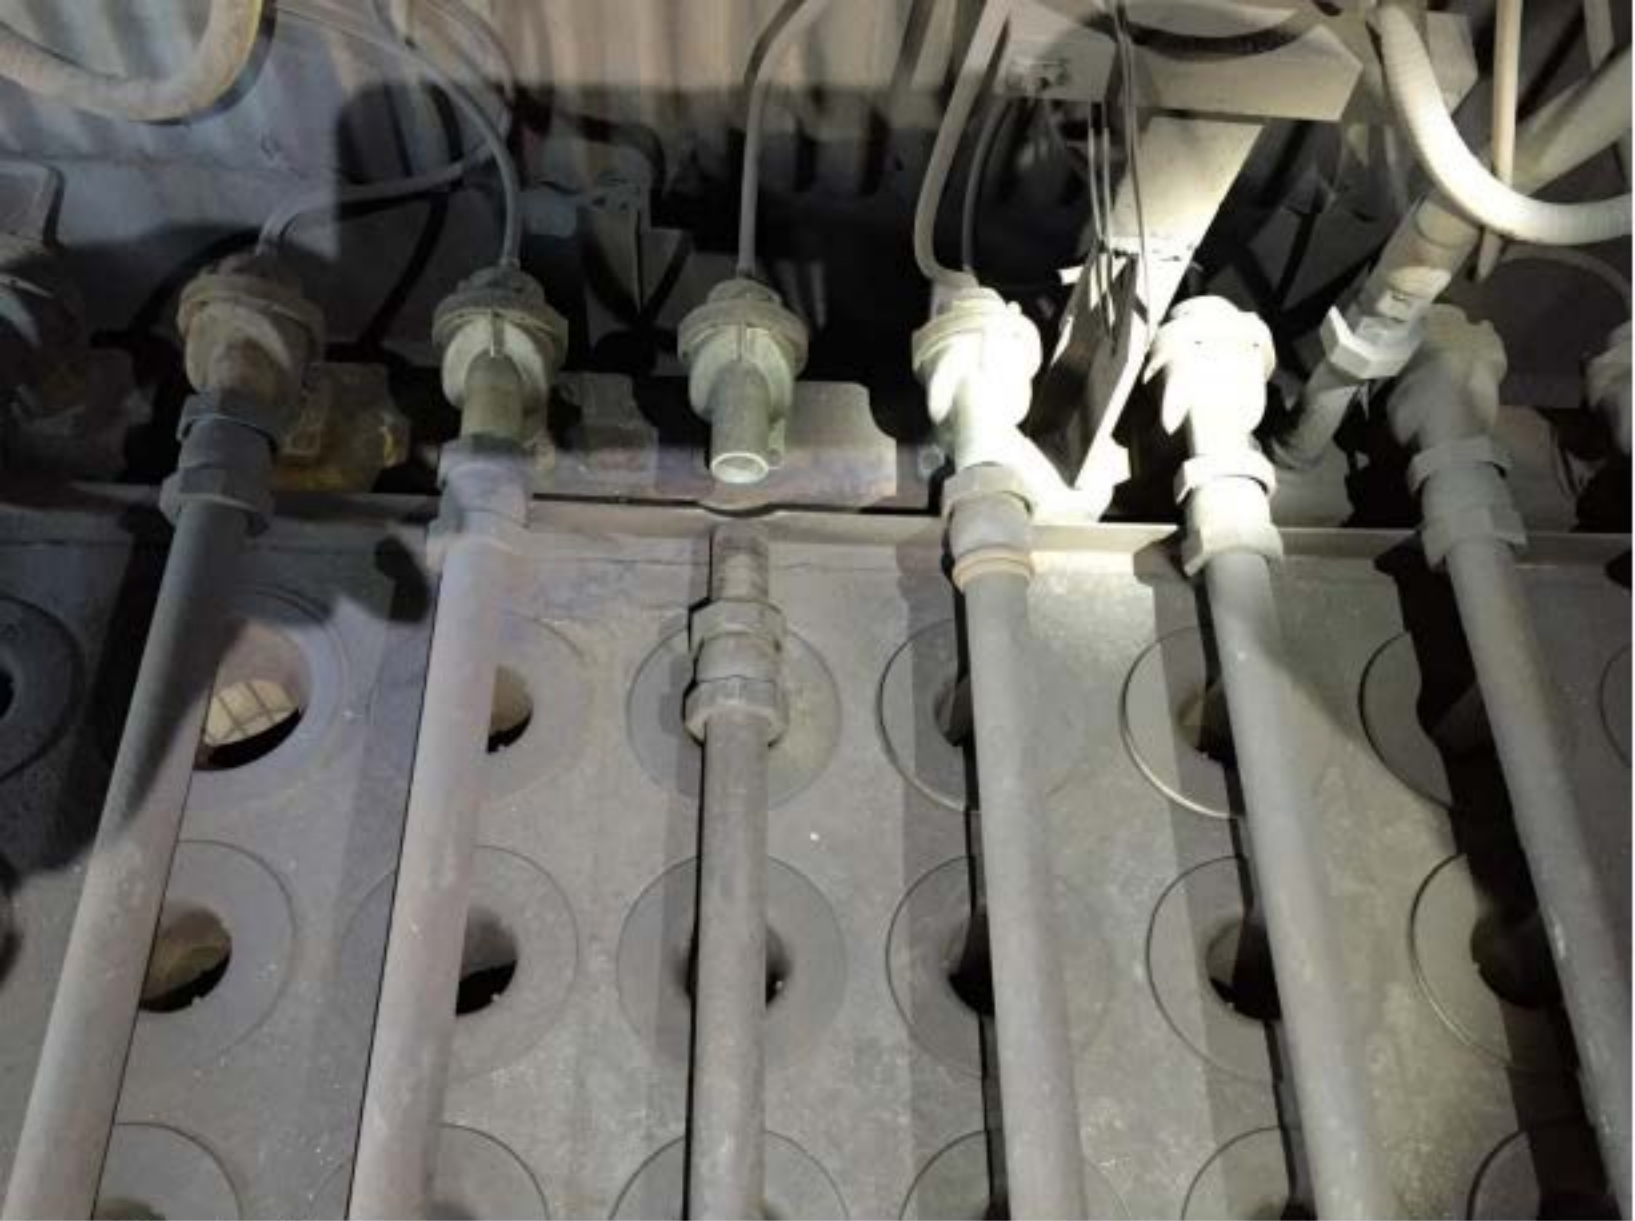
Figure 15 Blow pipe off

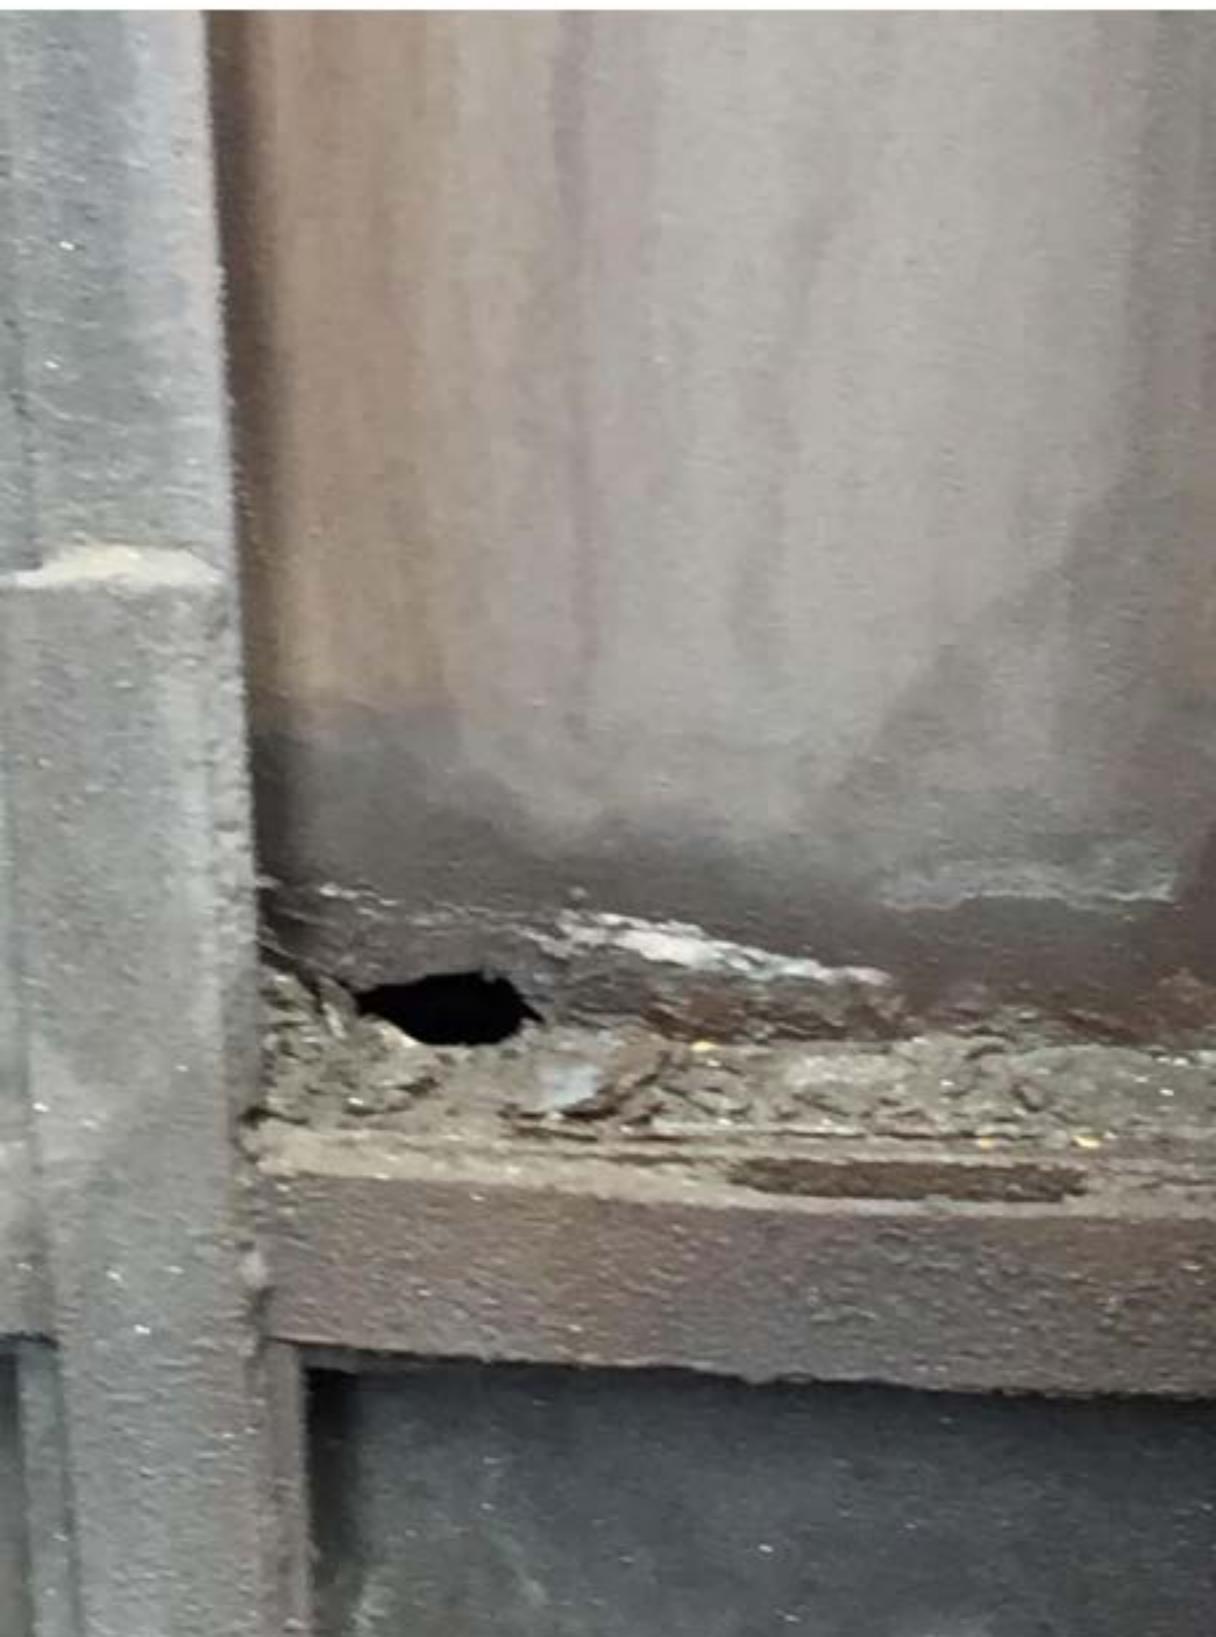
- Multiple locations on both sides of duct from furnaces where erosion has been repaired, where it is giving the appearance of distortion and where there are actual holes
- Inlet flange to Compartment #2 is giving appearance of leakage
- Expansion joints both inlet and outlet of fans appeared to be intact

Figure 17 Fan side duct hole
